MISCELLANEOUS PAPER GL-92-34

GEOPHYSICAL INVESTIGATION AT DUGWAY PROVING GROUND, UTAH

José L. Llopis, Jeffery S. Zawila

September 1992 Final Report

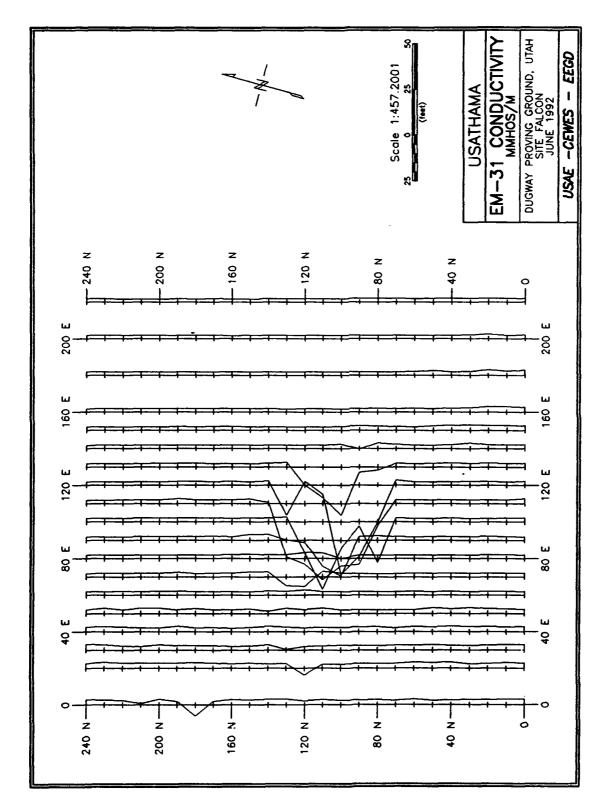
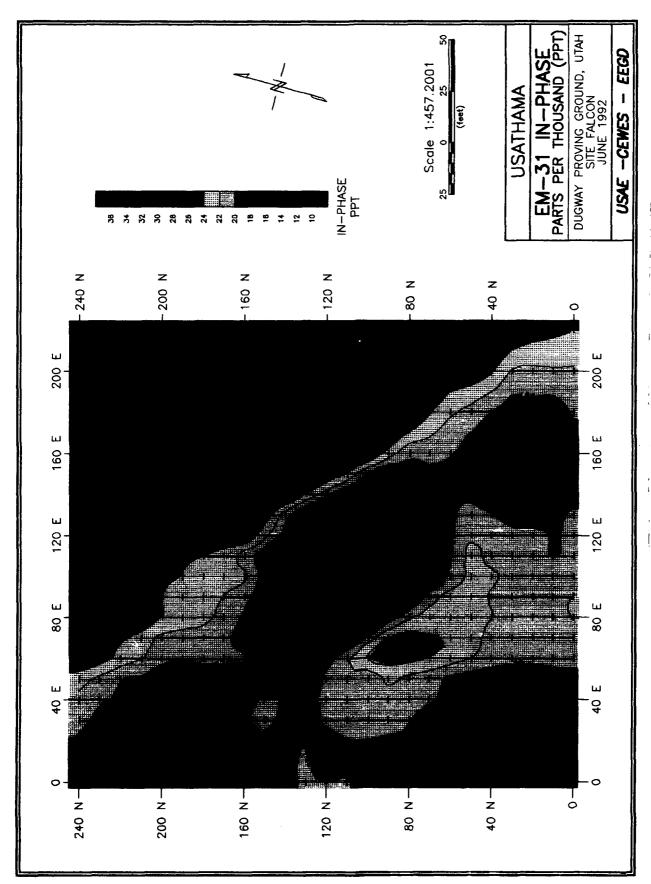
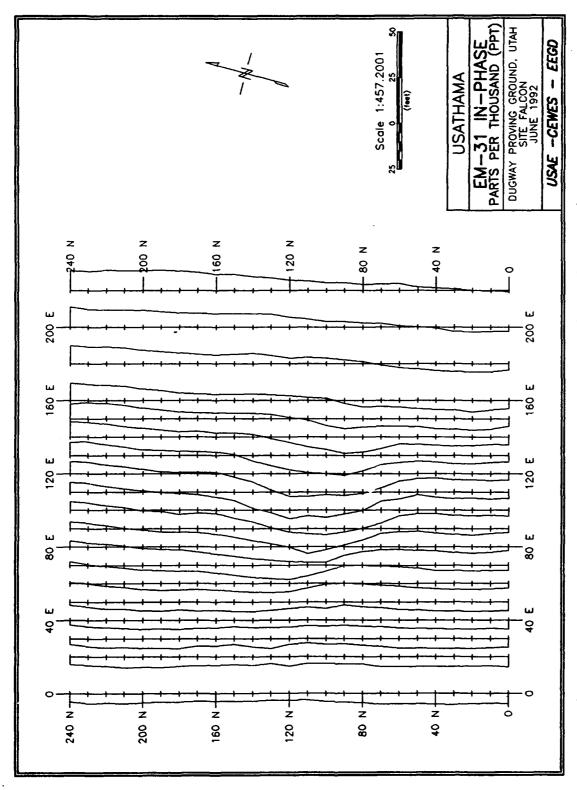
18. Site 186 was located to the west of Falconer Road (Figure 8). The center portion of this site was characterized by a mound consisting of gravel-to boulder-sized material (Figure 9). Oluic and Campbell (1992) report that this site contains a covered pit in which VX land mines were destroyed. A grid 240 ft by 220 ft was used to encompass the rocky mound. Figures 10 through 15 show the profile and contour maps obtained from the EM-31 and magnetometer surveys. The prominent anomaly detected by the EM-31 and the magnetometer was located in the center of the grid and approximately centered on coordinate (110E,100N). The EM-31 conductivity detected other minor anomalies across the site (Figures 10 and 11). The EM-31 in-phase results showed an increasing trend in values from the southwest to the northeast (Figures 12 and 13). In addition to the large anomaly centered in the grid, the magnetometer detected two anomalous areas centered on coordinates

Figure 10. EM-31 conductivity results, contour plot, Site 186

EM-31 conductivity results, profile lines, Site 186 Figure 11.

Figure 12. EM-31 in-phase results, contour plot, Site 186

EM-31 in-phase results, profile lines, Site 186 Figure 13.

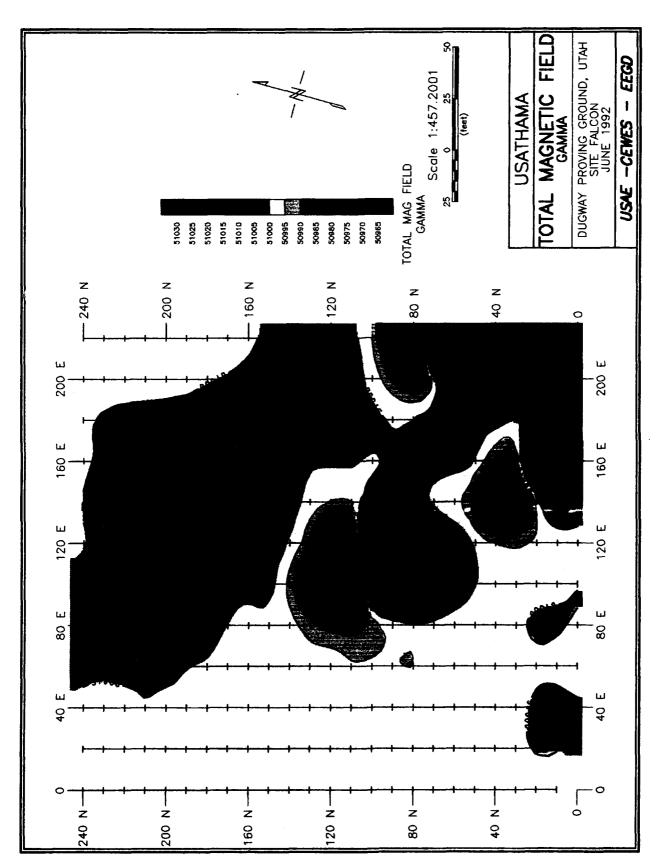
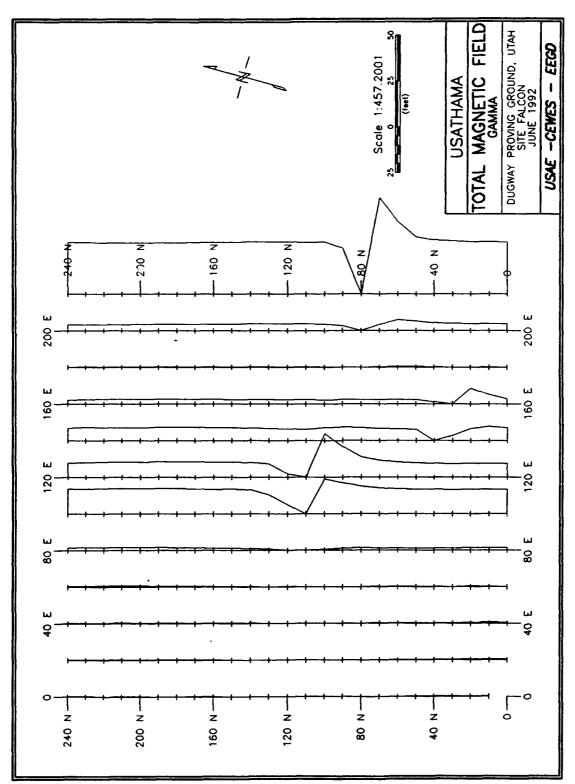
(150E,20N) and (220E,70N) as shown in Figures 14 and 15. The anomaly centered at (150E,20N) correlates with the location of metal pipes laying on the surface whereas, the interpreted anomaly at (220E,70N) is due to a section of railroad rail also laying on the ground surface.

Anomaly	EM-31		Mag	Anomaly Description
Location	Q	1		and Interpretation
(110E,100N)	x	x	x	Relatively low EM-31 cond. and in-phase readings. High-low magnetic anomaly. Anomaly probably due to buried ferrous object.
(150E,20N)			x	The location of this anomaly correlates well with the location of pipes laying on the ground surface.
(220E,70N)			X	The location of this anomaly correlates well with the location of a section of railroad rail laying on the ground surface.

Figure 14. Total magnetic field results, contour plot, Site 186

Total magnetic field results, profile plot, Site 186 Figure 15.

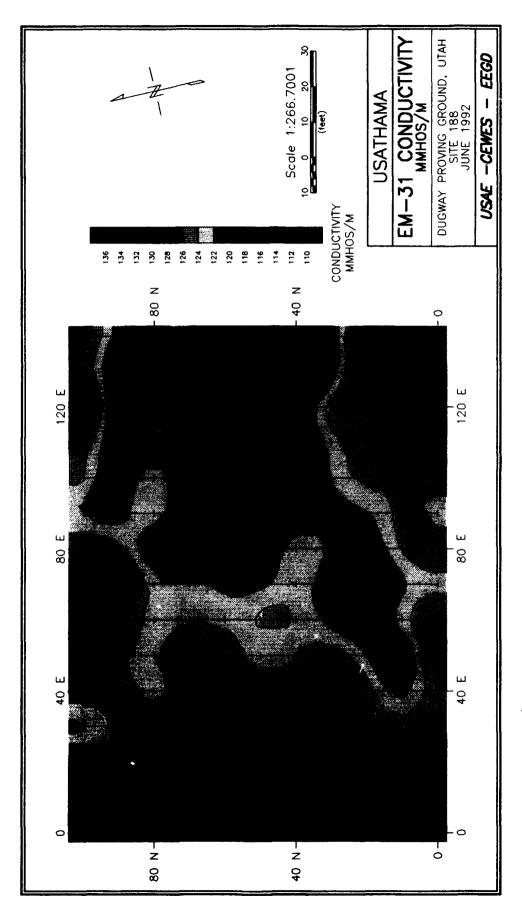
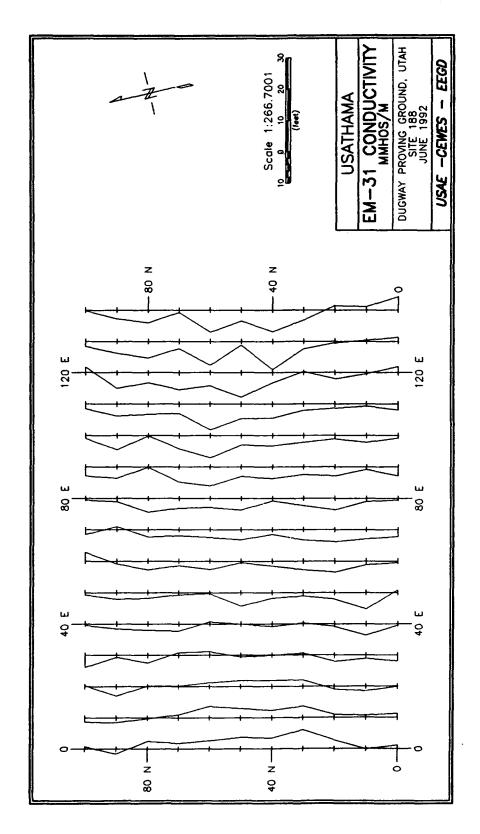
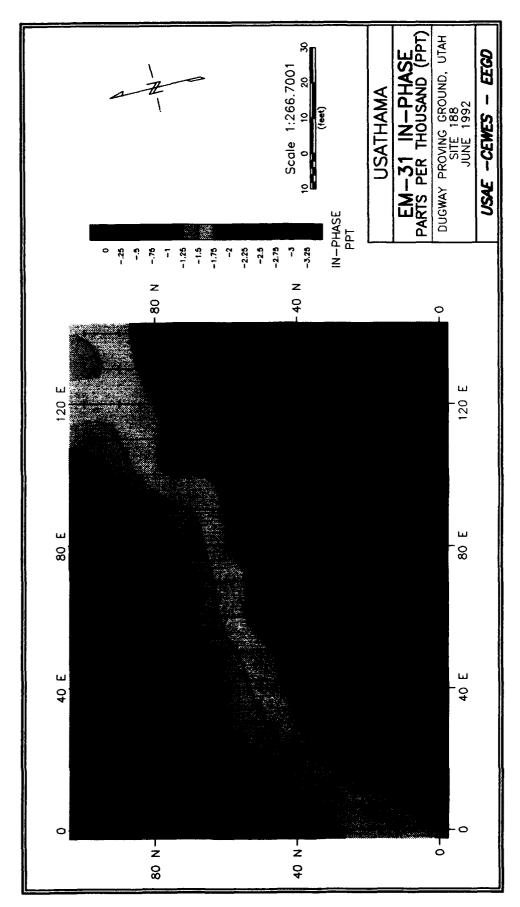
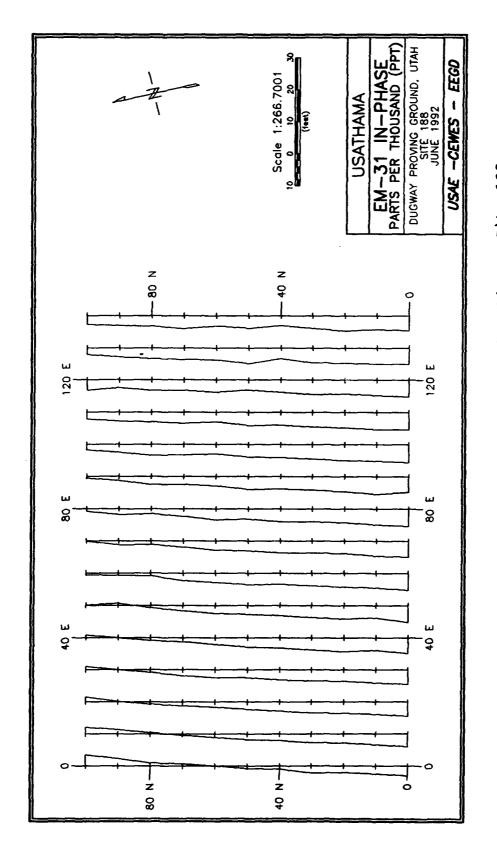
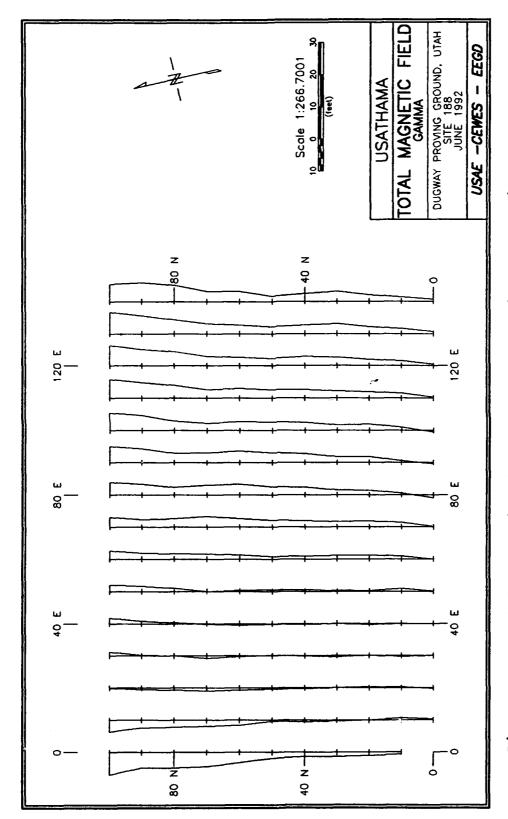
19. Site 188, located on the northwest side of Granite Peak, consisted of possibly several covered pits in which solid waste, mainly grease and wood, was disposed (Oluic and Campbell 1992) (Figure 6). The site was swept with the EM-31, EM-38 and magnetometer. An area with dimensions 100 ft by 140 ft was gridded and examined more closely with the EM-31 and magnetometer (Figure 16). The gridded site was selected because there was the appearance of disturbed soil and animal burrows. The EM-31 conductivity, EM-31 in-phase, and magnetometer results for Site 188 are presented in Figures 17 through 22. The EM-31 conductivity data indicated relatively low readings in an area centered on approximate coordinate (120E,60N) and higher readings on the western edge of the site (Figures 17 and 18). The area with the lower readings corresponds well with the location of the disturbed area shown in Figure 16. The EM-31 in-phase data indicates a general trend increasing from the southeast towards the northwest (Figures 19 and 20). The results of the total field magnetics indicated a magnetically "quiet" site with no interpreted anomalies (Figures 21 and 22). The range of the magnetic readings was only about 8 nt.

Anomaly	EM-31 Mag		Mag	Anomaly Description
Location	Q	I		and Interpretation
(100E,60N)	x			Relatively low soil conductivity readings. Possible soil disturbance. No buried ferrous material interpreted.
Western Edge	X			Relatively high soil conductivity values. Possible soil disturbance. No buried ferrous material interpreted.

Figure 17. EM-31 conductivity results, contour plot, Site 188

EM-31 conductivity results, profile lines, Site 188 Figure 18.

Figure 19. EM-31 in-phase results, contour plot, Site 188

EM-31 in-phase results, profile lines, Site 188 Figure 20.

Figure 21. Total magnetic field results, contour plot, Site 188

Total magnetic field results, profile plot, Site 188 Figure 22.

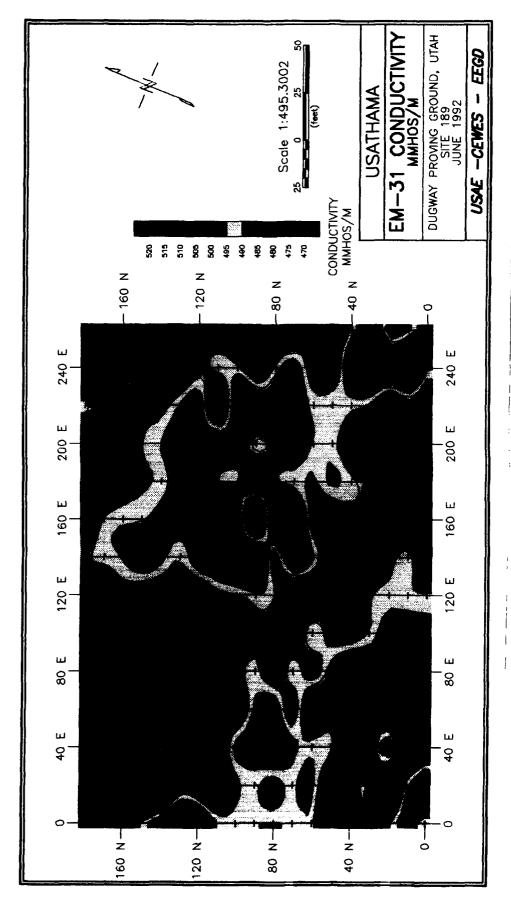
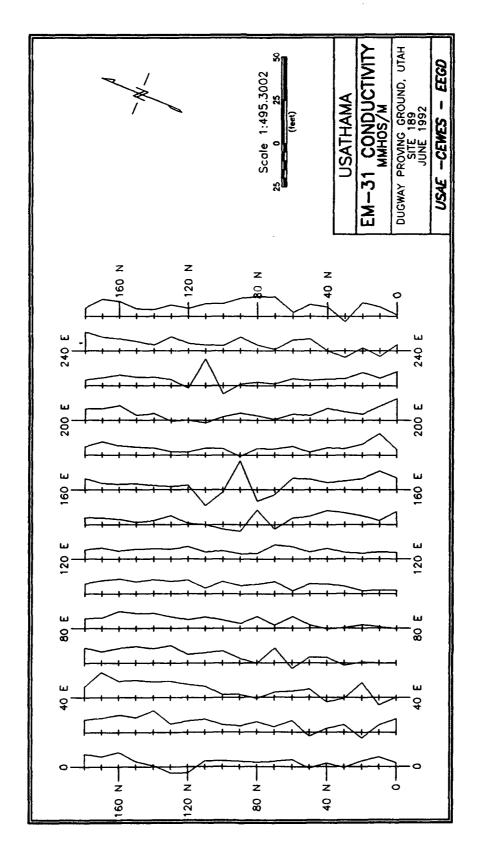
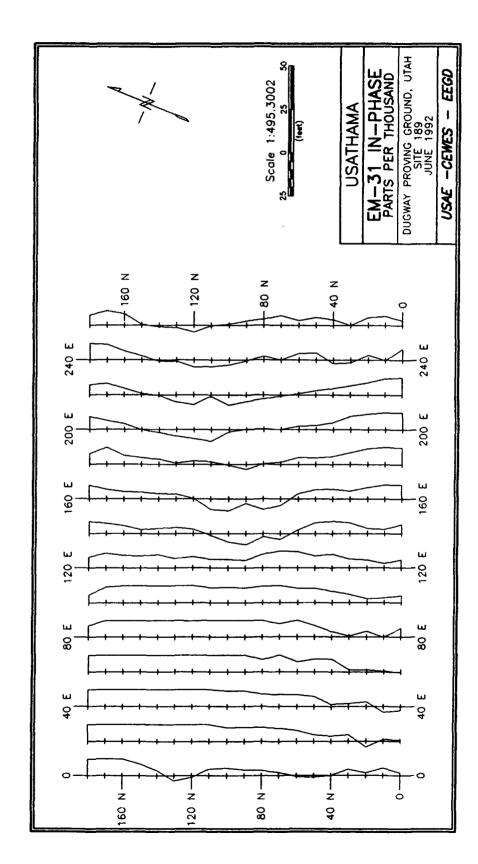
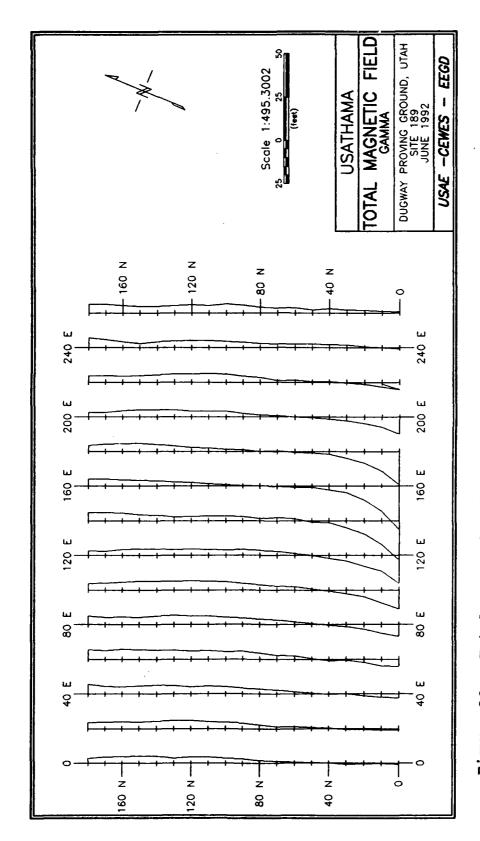
Site 189 was located south-southeast of Granite Peak and approximately 0.25 miles east of Government Well No. 52 (Figure 23). site supposedly consisted of covered pit(s) which contained projectile parts and mustard containers (Oluic and Campbell 1992). The area was swept with the EM-31, EM-38, and the magnetometer to determine the area needing closer investigation. An area 260 ft by 180 ft was selected for gridding based on the results of the sweeps and the existence of a bare area and various small depressions (Figure 24). The EM-31 conductivity and in-phase results indicated anomalously low readings in the southwestern and southeastern portions of the site (Figures 25 through 28). Also, two areas with anomalously low readings centered on approximate coordinates (150E,90N) and (220E, 110N) were detected by the EM-31 conductivity and in-phase. This area corresponds, in general, to the location of the bare spot. The results of the total magnetic field indicated no anomalous readings (Figures 29 and 30). The apparently low readings indicated in the southern portion of the site are caused by three vehicles parked nearby.

Anomaly	EM-31		Mag	Anomaly Description
Location	Q	I		and Interpretation
Southwest portion	x	x		Relatively low RM-31 cond. and in-phase readings. This area had various small depressions. Anomaly may be caused by soil disturbance, non-ferrous buried material, change in soil type, moisture, or salinity.
(150E,90N) (220E,110N)	X	X		Relatively low EM-31 cond. and in-phase readings. The location of these anomalies correlate well with the location of the bare ground surface. The anomalies may be caused by soil disturbance, buried non-ferrous materials, change in soil type, moisture, or salinity.
(160E,0N)			x	Magnetic low caused by presence of nearby parked vehicles.
(240E,30N)	X	x		Relatively low EM-31 cond. and in-phase readings. The location of the anomaly is not associated with the location of any visible object. The anomaly may be caused by soil disturbance, buried non-ferrous material, change in soil type, moisture, or salinity.

Figure 25. EM-31 conductivity results, contour plot, Site 189

EM-31 conductivity results, profile lines, Site 189 Figure 26.

Figure 27. EM-31 in-phase results, contour plot, Site 189

EM-31 in-phase results, profile lines, Site 189 Figure 28.

Figure 29. Total magnetic field results, contour plot, Site 189

Figure 30. Total magnetic field results, profile plot, Site 189

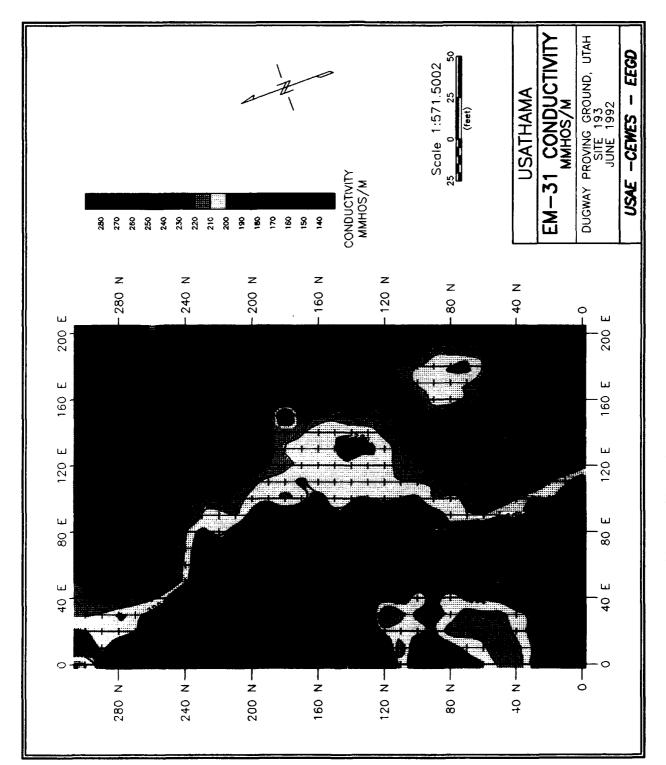
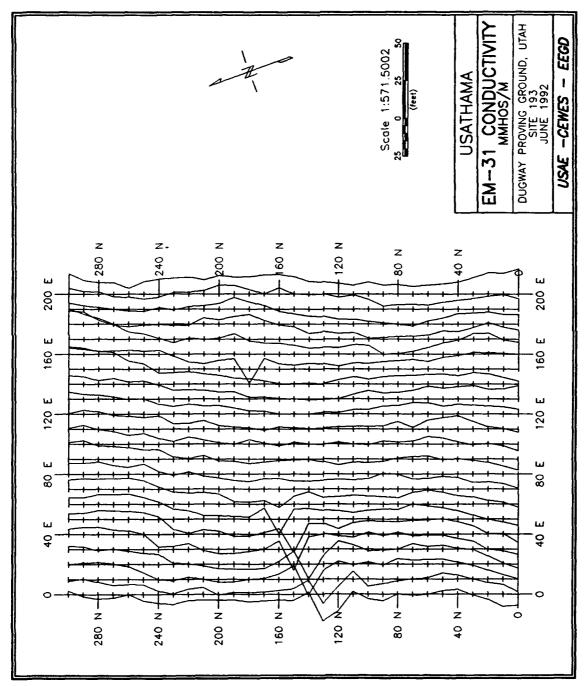
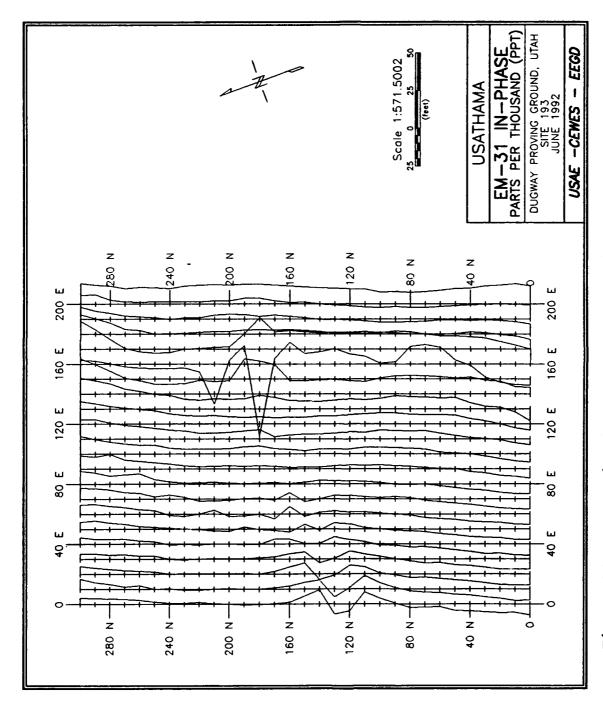
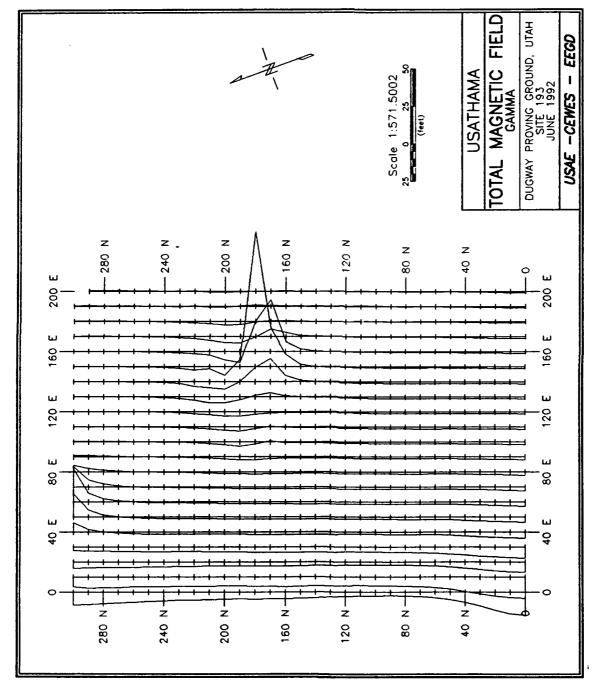
21. Site 193 was located in the Baker Area of DPG (Figure 31). More specifically, the site was located northeast of Building 2006 and covered an area 200 ft by 300 ft as shown in Figure 32. Oluic and Campbell (1992) report that the site consisted of an old pit possibly containing hazardous compounds. Zones with anomalously low and high values were detected by the EM-31 conductivity and in-phase. A zone with relatively low readings, centered between approximate coordinates (30E-60E,180N-240N) was detected by the EM-31 conductivity and in-phase as shown in Figures 33 through 36. Both EM-31 phases detected a northeast-southwest trending low originating at (00E,130N) and ending at approximately (70E, 150N). The EM lows located in the southwestern portion of the site may be caused by a nearby building and/or power line. Both EM phases show relatively high zones in the northeastern part of the site between (120E-200E, 260N-300N) and in the east central part near (180E, 190N). A small conductivity low was detected at (160E, 30N) as shown in Figures 33 and 34. The EM-31 in-phase data shows a north-south linear trending along line 160E and extending from approximately 10N to 200N as shown in Figure 35 and 36. The results of the total magnetic field survey detected two anomalous zones; the first at (60E,300N) and the second at (150E,190N) as shown in Figures 37 and 38. The first magnetic anomaly correlates well with the location of an above ground pipeline whereas, the second anomaly coincides with the location of an electrical control box, a concrete pad with a metal cover, and two small cast iron valve covers.

Anomaly	EM-31		Mag	Anomaly Description
Location	Q	I		and Interpretation
(30E-60E, 180N-240N)	x	x		Relatively low EM-31 cond. and in-phase readings. Anomaly may be caused by soil disturbance, non-ferrous buried material, change in soil type, moisture, or salinity.
(00E,130N) to (70E,150N)	X	x		Linear trending relatively low EM-31 cond. and in-phase readings bounded on both sides by higher readings. If the anomaly is extended to the northeast it intersects the location of sewer manhole covers thus, the anomaly may be a buried utility or sewer line or filled-in ditch.
Southwest Portion	x	X		Relatively low EM-31 cond. and in-phase readings. Anomaly may be caused by interference from nearby power lines and/or building.
(120E-200E, 260N-300N) and (180E,190N)	X	x		Relatively high EM-31 cond. and in-phase readings. The location of the anomaly is not associated with the location of any visible object. The anomaly may be caused by soil disturbance, buried non-ferrous material, change in soil type, or higher moisture or salinity content.

(160E, 10N-200N)		X		Linear trending anomaly with relatively high in-phase readings. The location of this anomaly corresponds with the location of dirt road leading to electrical box. Anomaly may be caused by differences between road and background materials or by a buried utility line underlying the road.
(150E, 180N)	x	x	x	These anomalies were caused by interference from electrical control box, concrete pad with metal cover, and cast iron valve covers.
(60E,300N)			x	Magnetic anomaly caused by above ground steel pipe line located approximately 20 ft north of the site.

Figure 33. EM-31 conductivity results, contour plot, Site 193

Figure 34. EM-31 conductivity results, profile lines, Site 193

Figure 35. EM-31 in-phase results, contour plot. Site 193

EM-31 in-phase results, profile lines, Site 193 Figure 36.

Figure 37. Total magnetic field results, contour plot, Site 193

Total magnetic field results, profile plot, Site 193 Figure 38.

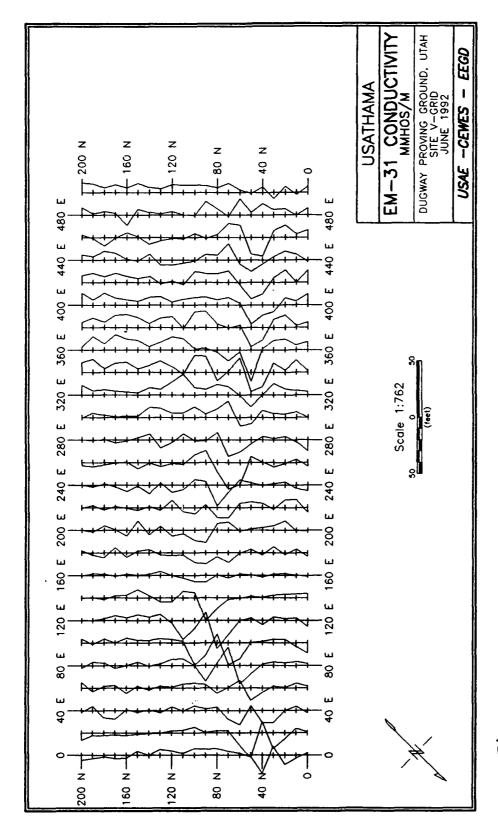
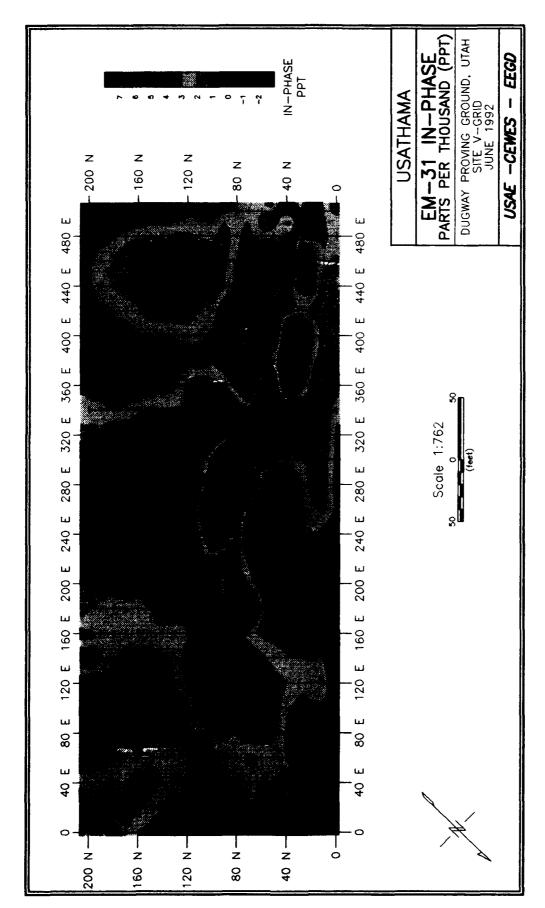
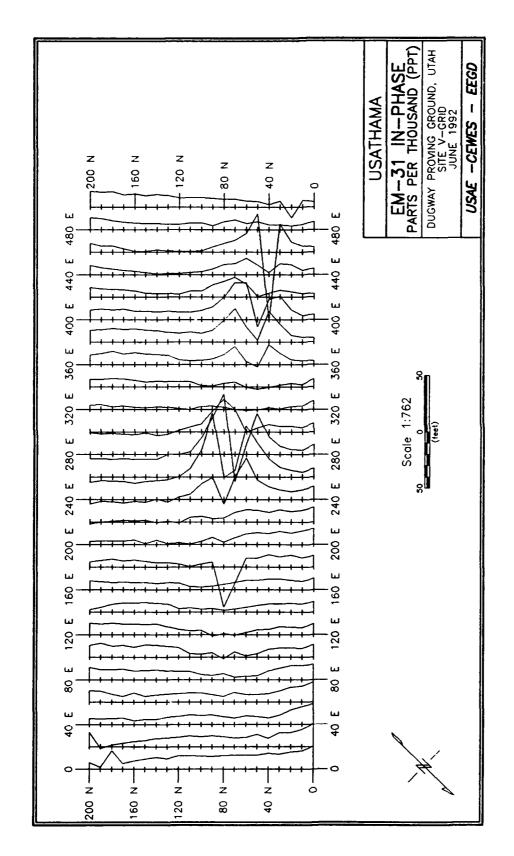
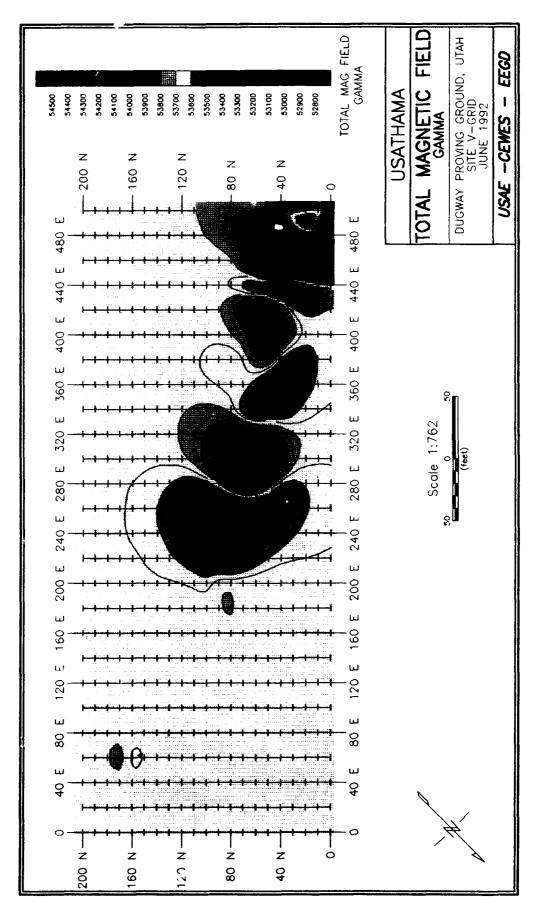
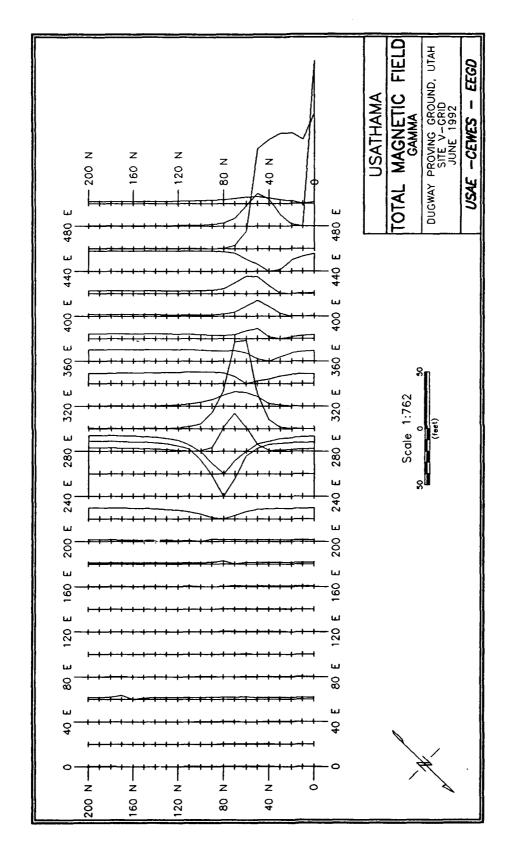
23. Site 196 was located north of Granite Peak, adjacent to V-Grid, as shown in Figure 8. According to Oluic and Campbell (1992) the area consists of a pit containing jars and bottles of VX. The site was characterized by, a what appeared to be, a man-made trench and ridge that ran across the site as shown in Figure 40. The area was swept with the EM instruments and magnetometer to detect possible anomalous zones. The EM-31, EM-38, and magnetometer sweep detected an anomalous area along the ridge. A grid was established at the site to encompass the trench and the ridge (Figure 40). The EM conductivity indicated an area of low values which corresponded with the location of the trench whereas, relatively higher values corresponded with

the ridge (Figures 41 and 42). The right-hand portion of the site was characterized by higher conductivity measurements. The EM-31 in-phase data shows three areas along the ridge that are identifiable by pairs of "bulls eye-like" highs separated by an area of relatively low readings (Figures 43 and 44). This type of feature is the expected characteristic high-low-high signature when crossing a metallic object. The EM lows situated between the pair of EM highs were located approximately at (260E,70N), (400E,50N) and (460E,40N). The EM-31 inphase readings did not appear to be significantly affected by the trench. The total field magnetic readings detected three significant anomalous areas characterized as "high-low" pairs (Figures 45 and 46). These anomalies are probably caused by buried ferrous objects. The objects are interpreted as being located at (280E,70N), (380E,50N) and (440E,30N). These three areas agree very well with the location of the three anomalies interpreted from the EM-31 in-phase data.

Anomaly	EM	EM-31 Mag		Anomaly Description
Location	Q	1		and Interpretation
(270E,70N) (390E,50N) (450E,40N)	x	x	x	Very large anomalies indicated by the EM and magnetometer. Anomalies occur along ridge. Probably buried ferrous material.
(180E,80N)		X	x	Small anomaly detected with the EM-31 in-phase and magnetometer. The location of this anomaly correlates well with the location of a section of landing mat and a stainless steel pan laying on the ground surface.

Figure 41. EM-31 conductivity results, contour plot, Site 196

EM-31 conductivity results, profile lines, Site 196 Figure 42.

Figure 43. EM-31 in-phase results, contour plot, Site 196

EM-31 in-phase results, profile lines, Site 196 Figure 44.

Figure 45. Total magnetic field results, contour plot, Site 196

Total magnetic field results, profile plot, Site 196 Figure 46.

- 31. If the decision to proceed to Corrective Measures is made, it is recommended that selected geophysical anomalies be excavated to determine the nature (e.g. solid, liquid, contained, or uncontained) and extent of the anomalies. If hazardous materials are encountered and their location ascertained, options for disposition of the material should be considered at that time.

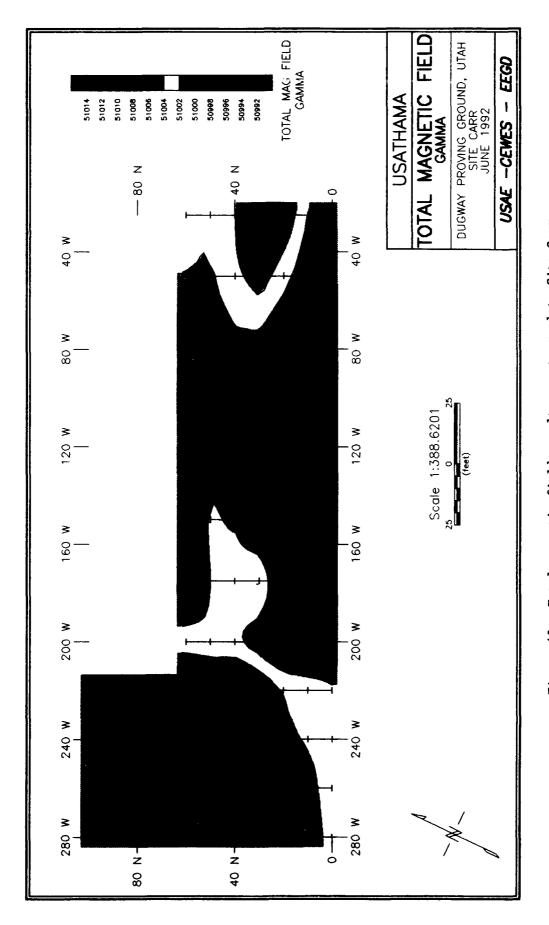
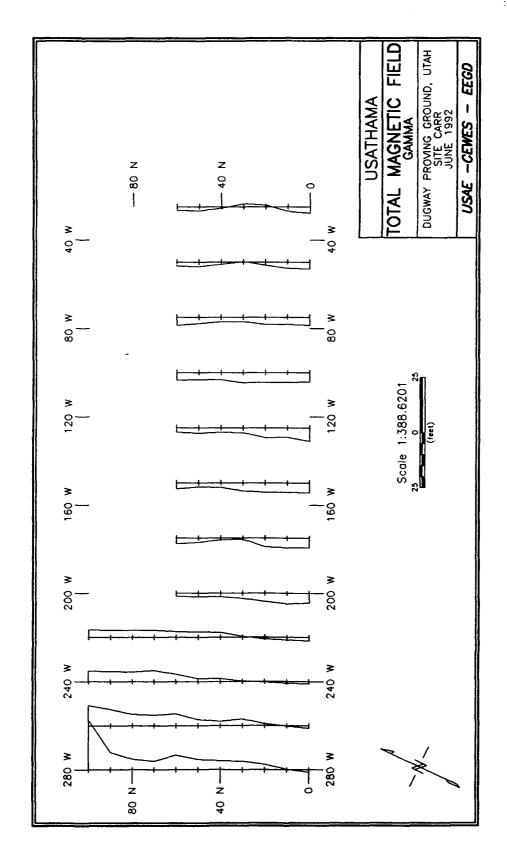
5 ft by 5 ft fenced area and it is not known what, if anything, is buried within the area. The site was swept with the EM-31 and no anomalous features were detected. However, because of the suspicious nature of the ridge and fenced area, a grid was set up for the magnetometer. The grid was approximately 280 ft by 100 ft as shown in Figure 49. Prior to conducting the magnetometer survey, the metal fence was pulled-up and moved away from the gridded area, to a location far enough away from the grid to prevent interference with the magnetometer. A magnetic high is noted in the northwest section of the site and is probably caused by the pulled-up metal fence (Figures 49 and 50).

Figure 49. Total magnetic field results, contour plot, Site Carr

Total magnetic field results, profile plot, Site Carr Figure 50.
